“Full” Reserve Study

Capitol City Golf Club Estates Olympia, WA

Report #: 30110-0

Date Prepared: March 4, 2016

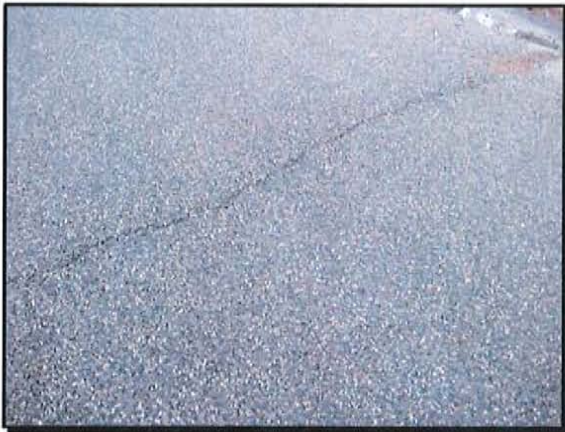
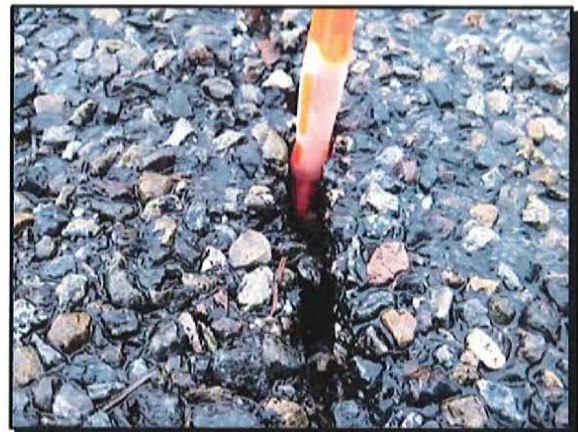
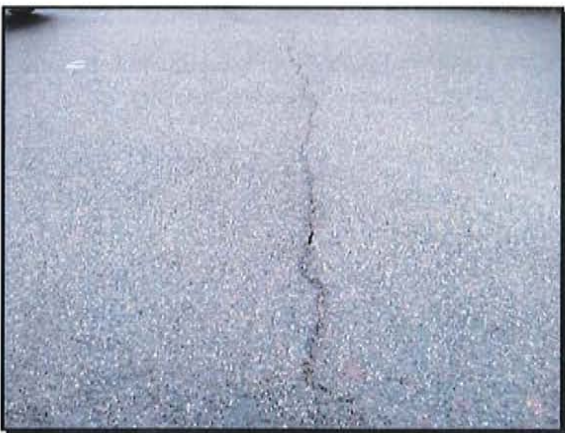
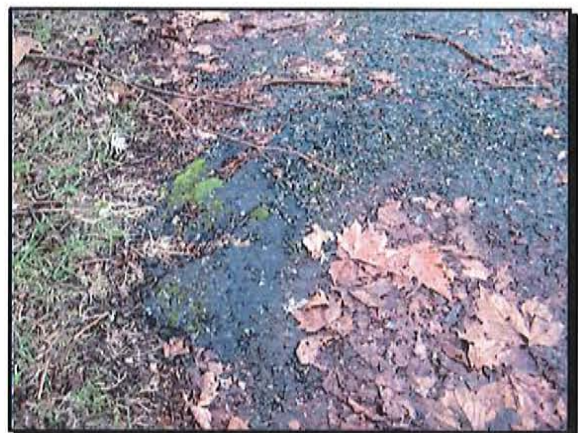
During our site inspection we learned that the association had applied a chip seal to the roads in 2014. We observed tree root uplift and cracking in areas, and recommend prompt repair to prevent water from penetrating down to the base of the asphalt.

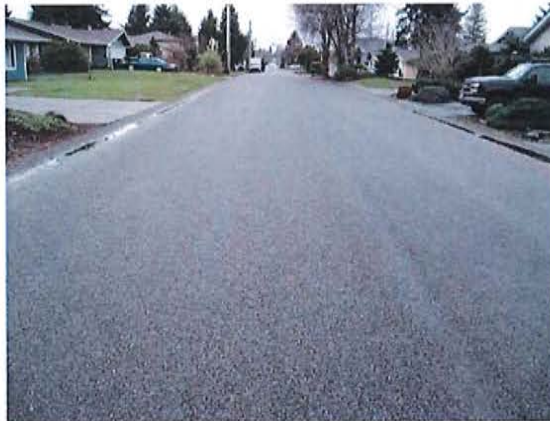
Comp #: 120 Asphalt - Resurface (Overlay) **Quantity:** ~ 590,300 GSF asphalt
Funded?: Yes
History: None known
Location: Roadways within community
Evaluation: Asphalt surface was covered by recent chip seal, therefore surface appeared relatively intact. Local cracking, tree root uplift, moss growth, faded paint (primarily on speed bumps) and low spots were observed in areas. Chip seal is a wearing course, not structural; therefore repaving will be necessary at some point.

Note: Plat map reflects both private and public roads, however our source reported that all roads within community have been deeded to the association to maintain, repair and replace. As a result, all roads are included within this component.

Useful life below assumes regular surface treatment and repairs (see component #121). The lack of surface treatment and repairs can greatly decrease the asphalt's useful life. Resurfacing is typically one of the larger expense items in a reserve study. When need to resurface is apparent within a couple of years, consult with geotechnical engineer for recommendations, specifications / scope of work and project oversight.

As routine maintenance, keep surfaces clean and free of debris, ensure that drains are free flowing, repair cracks, and clean oil stains promptly. Assuming proactive maintenance, plan to resurface at roughly the time frame below.

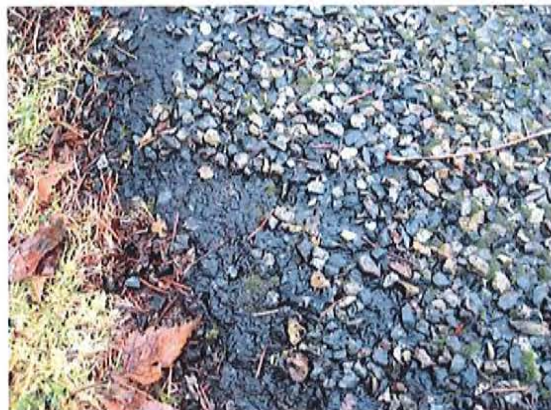
History: Chip seal 2014 ~ \$50k
 Location: Roadways within community
 Evaluation: Generally, the surface condition of the asphalt coating appeared to be in stable condition. It was reported that a chip seal was applied in 2014 at a cost of ~ \$50k.

Regular cycles of surface treatment, along with needed repairs is a best practice for the long term care of lower traffic asphalt areas to extend the useful life.

The State of Washington Department of Transportation (WSDOT) recommends regular cycles of surface treatment for the long-term care of asphalt paving with low traffic and low speed. The primary reason to surface treatment of asphalt is to protect the pavement from the deteriorating effects of sun and water. When asphalt pavement is exposed, the asphalt oxidizes or hardens and this causes the pavement to become increasingly brittle. As a result, the pavement will become more likely to crack, as it is unable to bend and flex when subjected to traffic (weight) and temperature changes (thermal expansion and contraction). A seal coat combats this situation by providing a waterproof membrane, which not only slows down the oxidation process, but also helps the pavement shed water. Surface treatment also provides uniform appearance and conceals the inevitable patching and repairs which accumulate over time, ultimately extending the useful life of asphalt before more costly resurfacing is needed (see component #120).

Repairing asphalt before surface treatment is imperative. Surface preparation and dry weather during and following application, is key to lasting performance. The ideal conditions are when the air and surface temperatures are 50 degrees and rising, with low humidity and calm wind. Project should never be done when showers are threatening. Incorporate any striping and curb repair into this project. Fill cracks and clean oil stains promptly in between cycles as routine maintenance.

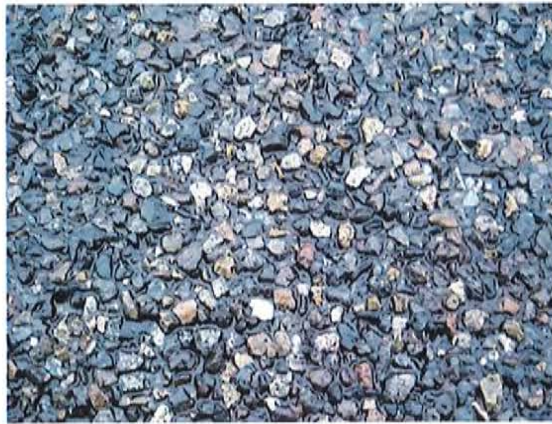
Useful Life:
10 years

Remaining Life:
27 year(s)

Best Case: \$ 47,200.00
~ \$0.08/SF, lower allowance to
apply chip seal

Worst Case: \$ 70,800.00
~ \$0.12/SF, higher allowance

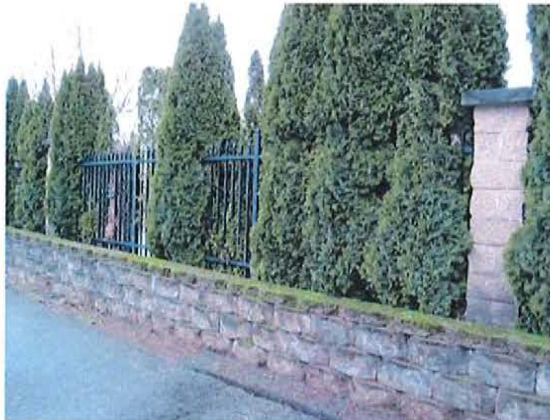
Comp #: 157 Retention Wall/Fence - Replace **Quantity:** Extensive LF
Funded?: No Association reported City is responsible to maintain/repair/replace
History: None known
Location: Adjacent to sidewalk along Yelm Highway
Evaluation: It was reported to us that concrete masonry unit (CMU) walls and metal fencing at public sidewalk along Yelm Highway were installed by the City during street improvements and are therefore not the responsibility of Capitol City Golf Estates to maintain, repair or replace. As a result, no reserve funding included.

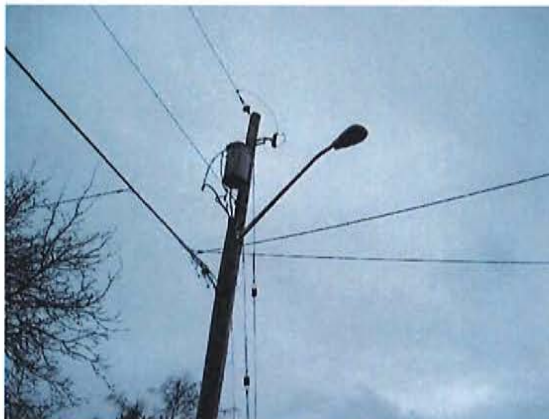
Comp #: 160 Pole Lights - Replace **Quantity:** Cobra head lights
Funded?: No Utility responsibility to maintain/repair/replace
History: None known
Location: Utility poles adjacent to streets within the community
Evaluation: Community features commercial grade cobra head street lights attached to utility poles throughout the community. Poles are labeled with IntoLight barcodes, indicating that they are the responsibility of Puget Sound Energy to maintain, repair and replace. As a result, no reserve funding is included.

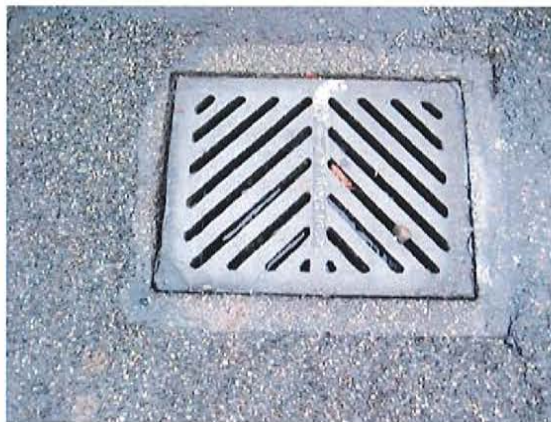
No predictable large-scale repairs/replacement at this time. Local repairs should be performed as part of general maintenance. If problems become known from professional evaluation, funding can be included in future reserve studies.

As routine maintenance, inspect regularly and keep drains/grates free of debris to ensure water drains as intended. Maintenance schedules on stormwater systems depend on the condition of the system itself and the amount of sediment and debris moving around on site. Stormwater inspections usually consist of inspecting the catch basins and manholes, ensuring vaults and control structures are properly functioning. Evaluation of drainage can include the visual review of interior drain lines by use of miniature remote camera. Clean out drain lines and basins as often as needed in order to prevent decreased drainage capacity. Repair as needed. The responsibility of keeping the stormwater system in good working order falls on the association.

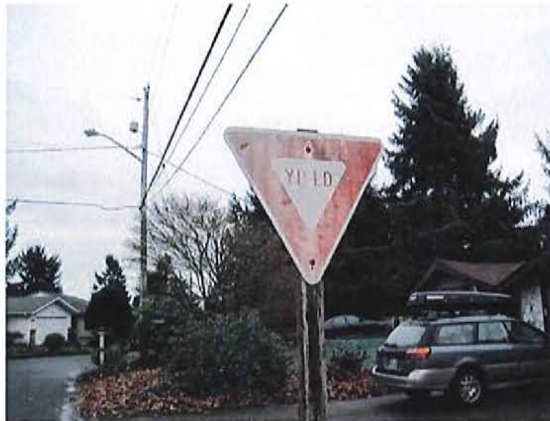
Comp #: 200 Signage - Replace **Quantity:** ~ (112) metal signs
Funded?: Yes
History: None known
Location: Adjacent to streets within community
Evaluation: Street signs within the community were primarily constructed of metal. Condition of signs varied, with some signs observed to be severely faded and a handful of signs were delaminating. Several posts were observed to be leaning.

Prudent financial planning suggests setting aside funds for periodic replacement of street signs to maintain appearance and legibility. As routine maintenance, inspect regularly, clean as needed and replace damaged signs out of the general maintenance operating budget in between larger replacement cycles.

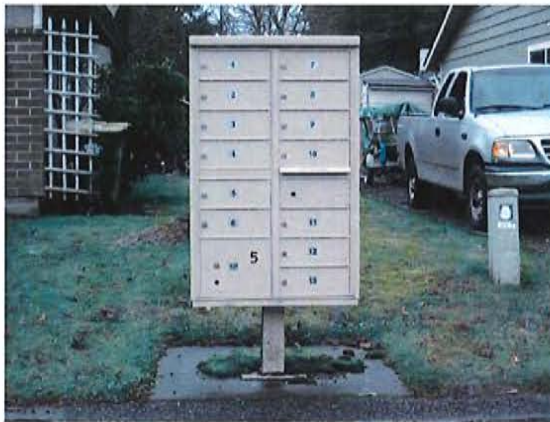
Comp #: 205 Mailboxes - Replace

Evaluation: Mailboxes appeared in generally intact condition with some dirt/grime observed in areas. No problems or concerns were reported. Mailboxes are not protected from the rain by a structure. Manufacture dates range between 2006 and 2008, with one cluster box unit on 66th Ave SE dated 2014; we have used 2007 as the average age for financial planning purposes.

In our experience, it is best to plan for total replacement at roughly the time frame below due to constant usage and wear over time.

As routine maintenance, inspect regularly, clean by wiping down for appearance, change lock cylinders, lubricate hinges, and repair as needed from operating budget.
